INTERNAL CORRESPONDENCE

SUBJECT: ECO Matrix and rework for IPB, IOC, DRR Boards REV 3

This document contains the rework required to up-grade the IOC, IPB, DRR Channel and interface boards to the latest correct dash and REV level.

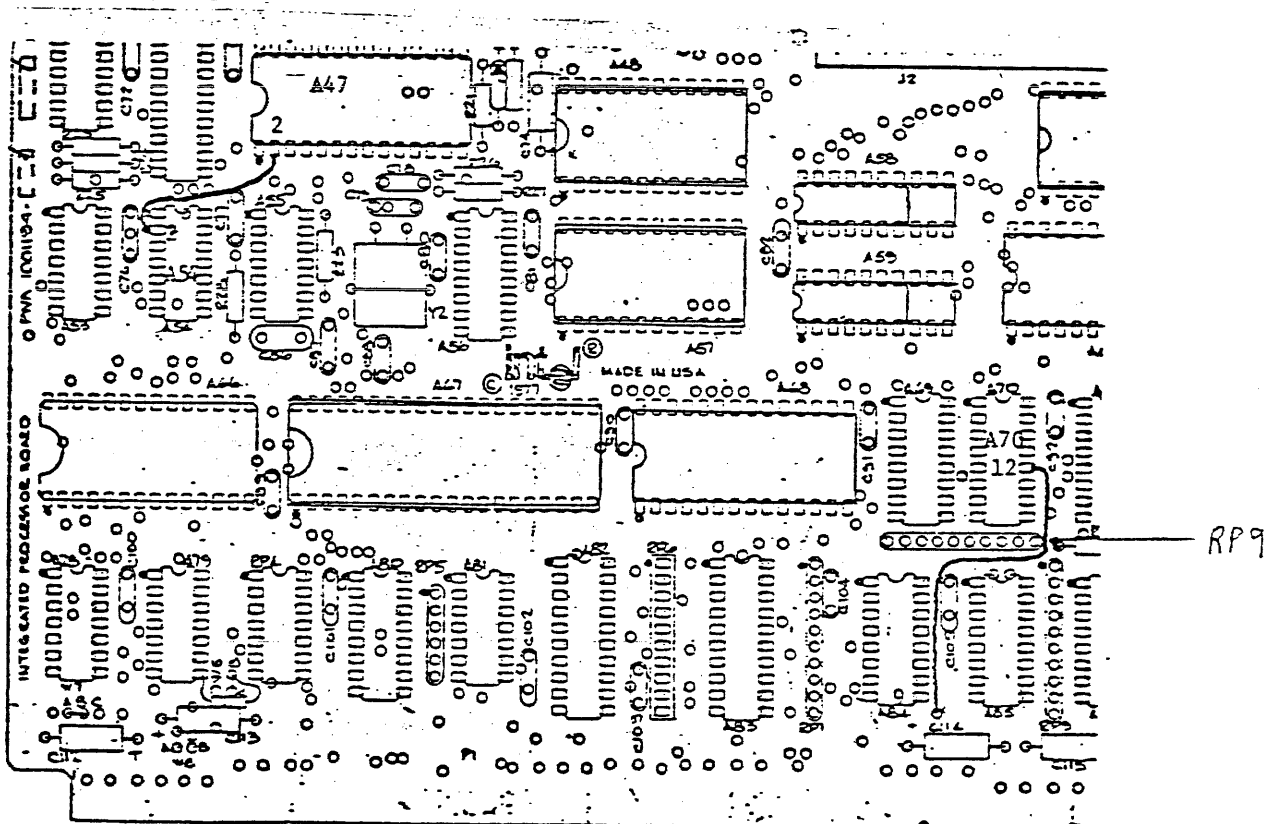
FIGURE 1

ECO 2-4594A

3. On solder side, cut the trace running from RP9-3 to the feed thru located near A84-9. (See figure 1).

4. On component side, install a jumper from the feed thru located below and to the right of A84-9 to A70-12.
5. On component side, install a jumper from the lead of A54-2 to A47-2.

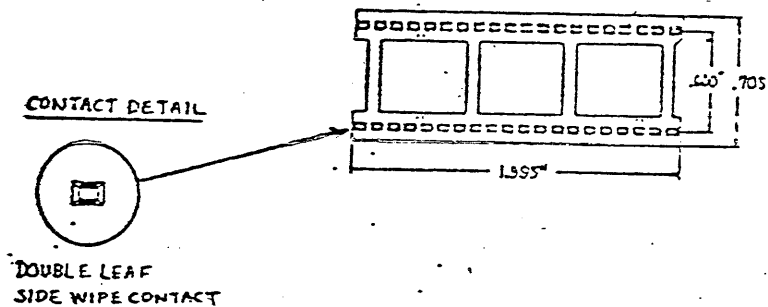
ECO 2-4556A

The 40-pin sockets to be replaced are Intel P/N 101555-040 (typical example shown below):

3. If PWA does have the above sockets, remove all 40-pin sockets shown above.
If PWA does not have this type of socket, replace IC's in sockets (socket is then of the right type).
4. Replace 40-pin socket with Scanbe or Augat type socket (P/N 101581-040 or 102989-001).
5. Replace IC into socket.

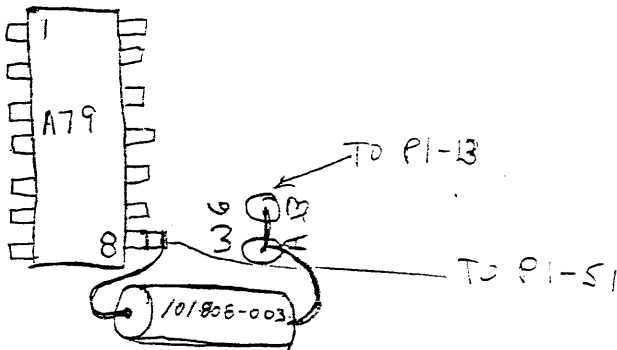
ECO 1945

Add .22 uh choke to clock service line

1. Clip pin A79-8 flush with PCB and bend up pin.
2. Solder choke .22 uh (101808-003) from A79-8 to adjacent jumper wire as shown in below.

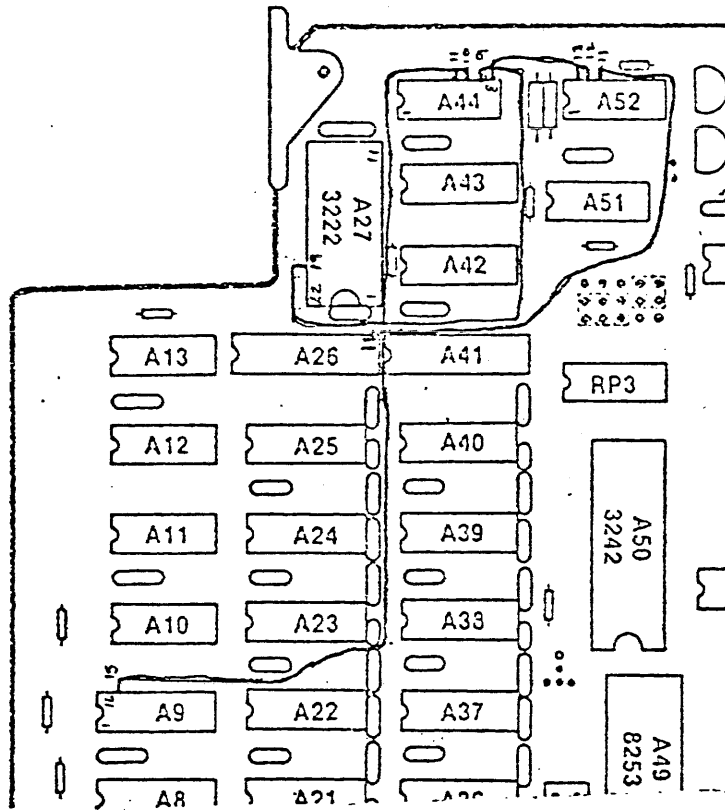
FIGURE 1

ECO 2210

ROUTING FOR ECO 2210

1. Replace all 74S74 (100913-001) with 74LS74 (100914-001)
2. Cut trace from A9-15 to A26-11
3. Add jumpers as follows, (see figure 1):

<u>FROM</u>	<u>TO</u>
A27-19	A44-9
A9-15	A44-10 & 11
A44-8	A52-12 & 13
A52-11	A26-11

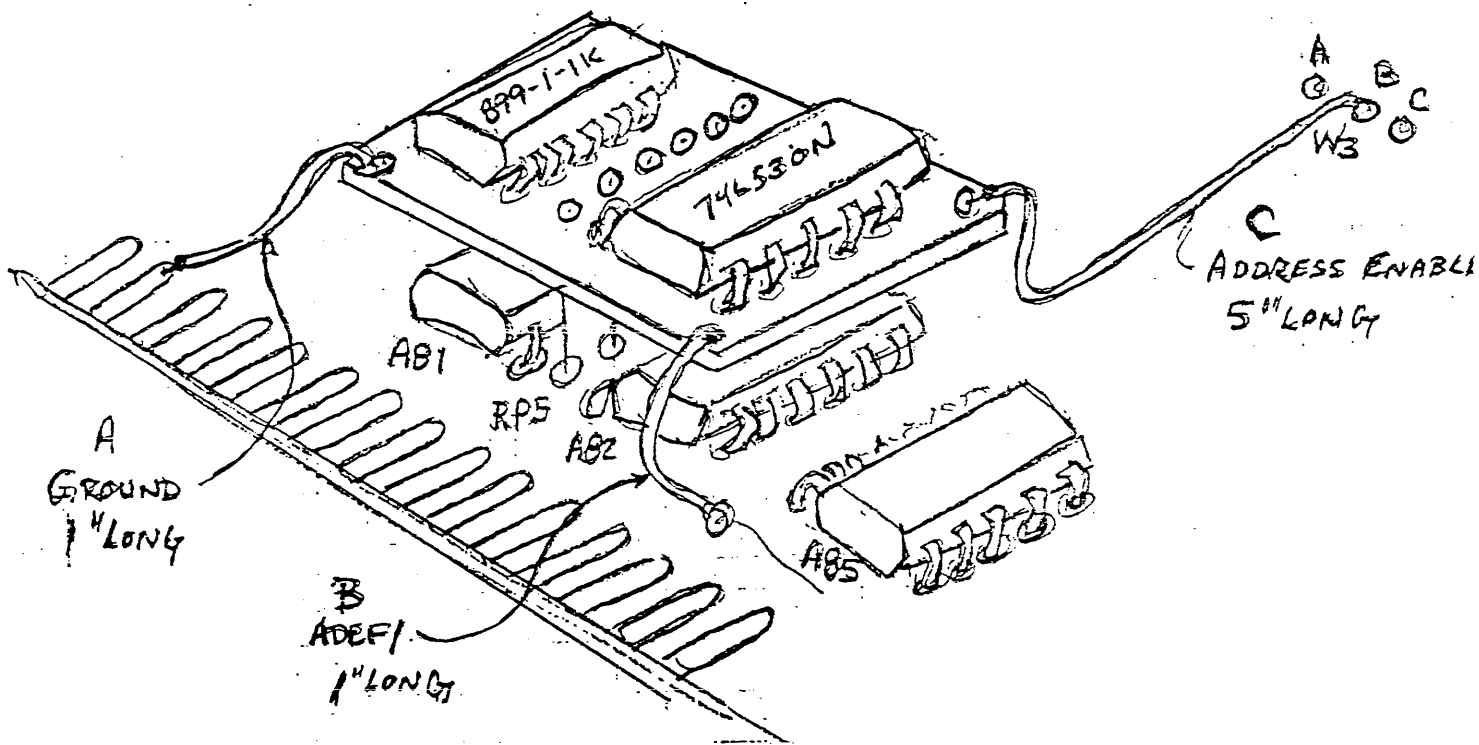
P/N 1002234-01

*** All 1001194 boards must have the 20 bit address modification added before the boards may be shipped. This FIX will allow all IPB's to be interchangeable. An ECO is being written to correct this problem.

1. Remove RP5, A SIP resistor package
2. Fit prongs of piggy-back board into holes of RP5 and solder
3. Solder Jumper A to ground
4. Solder Jumper B to ADRF/ at feed through
5. Solder Jumper C to jumper feed through W3-B

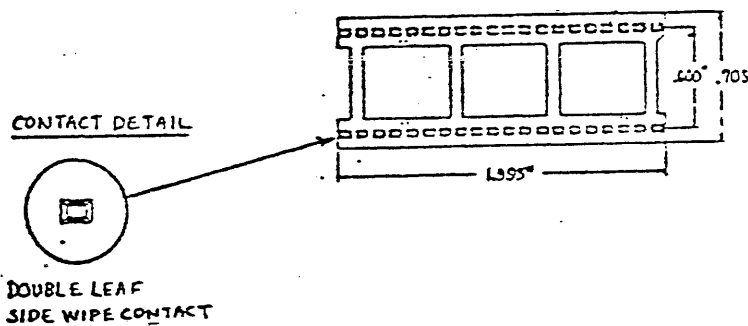
ECO 2-4565

1. Remove 40 pin IC's at locations A1, A20, A58, A69 and A72.
2. Inspect 40 pin sockets for the type shown below:
The 40-pin sockets to be replaced are Intel P/N 68-234 (typical example shown below)

3. If PWA does not have this type of socket, replace IC's in sockets (sockets are then of the right type).
4. If PWA does have the above sockets, remove all 40-pin sockets shown above.
5. Replace 40-pin sockets with Scanbe or Augat type (P/N 102989-00 or 101581-040)
6. Replace IC's in sockets

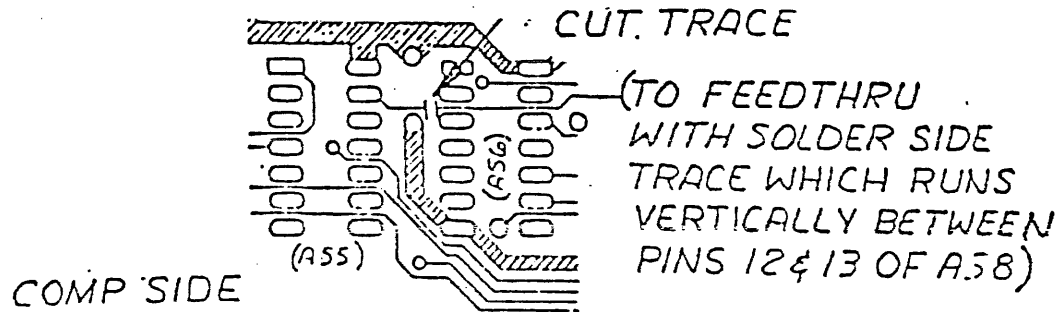
ECO 2-3629

1. Cut trace running to A55-13, from feed thru

2. Add jumper wire from feed thru just cut to A56-2
3. Add jumper from A72-7 to A72-20 (GND)

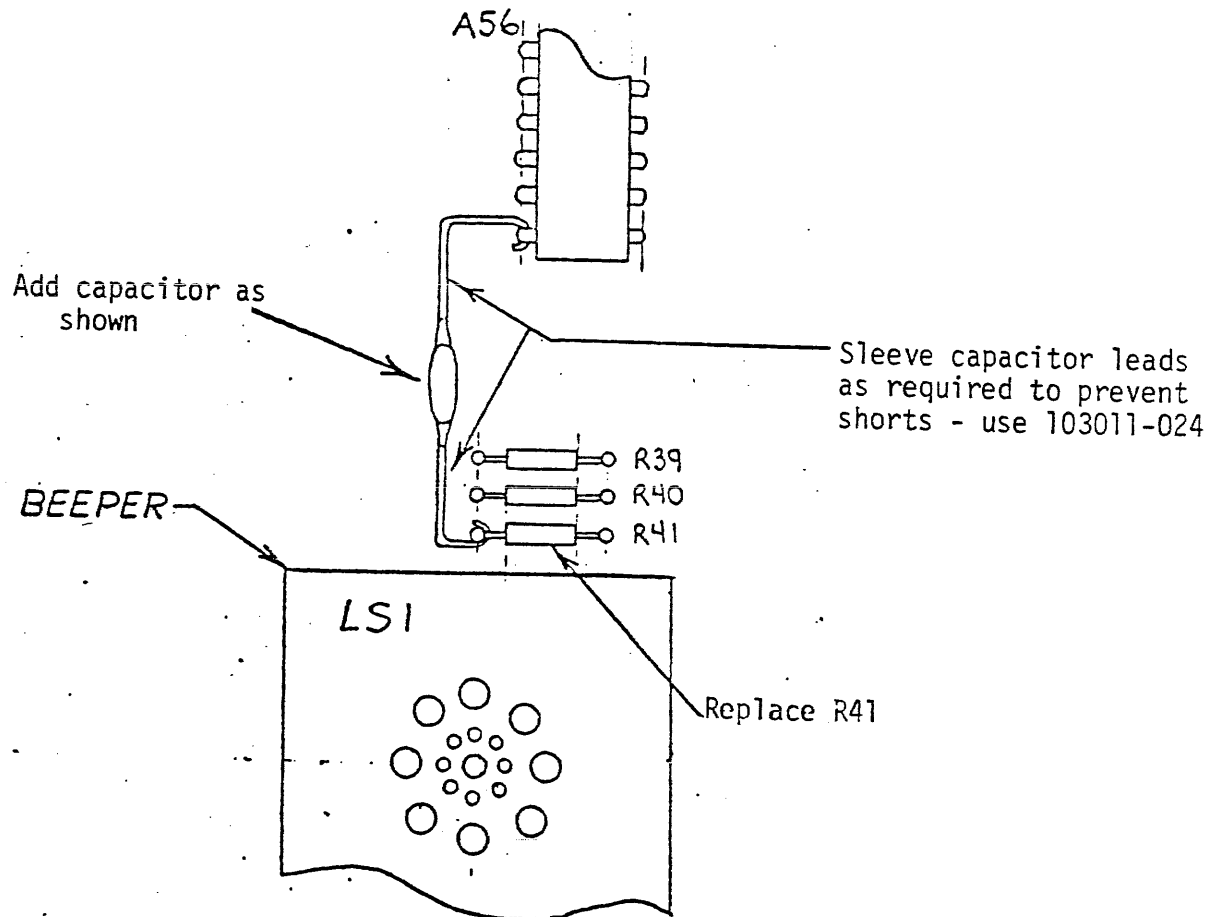
ECO 2-5304

1. Remove resistor R41 (1K 5% $\frac{1}{4}W$) and replace with:
(1ea) 101656-06Z resistor 750 $\frac{1}{4}W$ 5%.
2. Add (1ea) capacitor P/N 101754-049, CER. 0.1 UF 50V. Between A56-7 (gnd)
and R41, per sketch below. (Sleeve leads as shown)

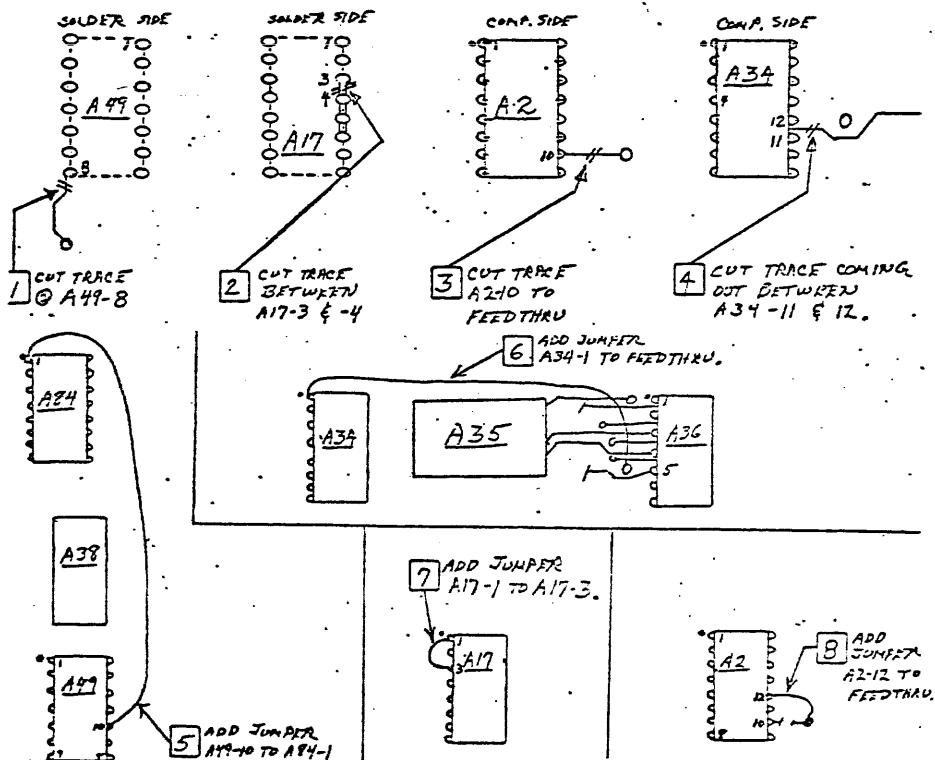
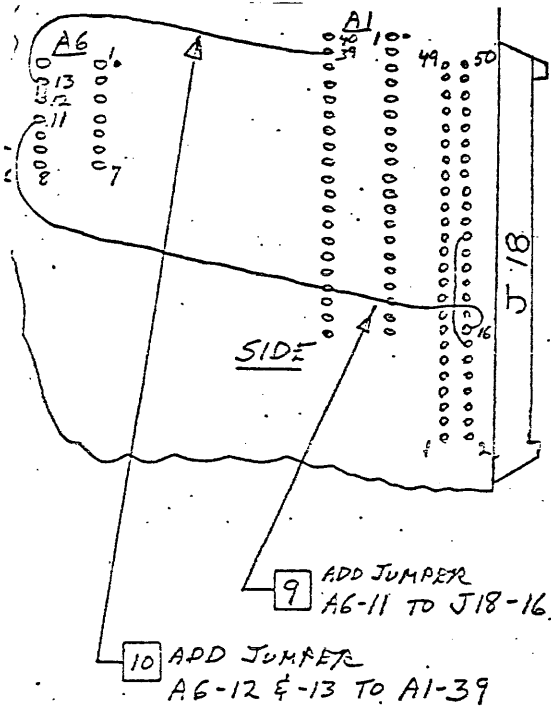
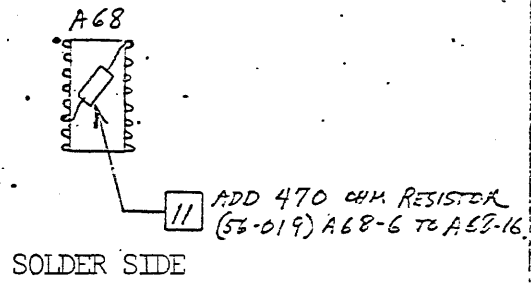
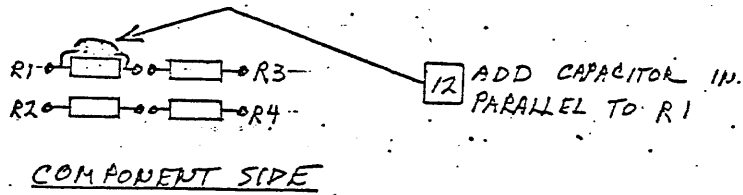
ECO 2-2699A

1. Cut trace (solder side) at A49-8.
2. Cut trace (solder side) between A17-3 and A17-4.
3. Cut trace (component side) A2-10 to feed through.
4. Cut trace emerging from under A34 (comp. side) between pins.
5. Add jumper from A49-10 to A84-1 (component side)
6. Add jumper from A34-1 to feed through adjacent to A36-5 (component side)
7. Add jumper from A17-1 to A17-3 (component side)
8. Add jumper from feed through adjacent to A2-10 to A2-12 (component side)
9. Add jumper from A6-11 to J18-16 (solder side)
10. Add jumper from A6-12 & 13 to A1-39 (solder side)
11. Add (1 ea.) 470 Ω resistor (P/N 101656-022) from A68-6 to A68-16 (component side)
12. Add capacitor C-90 in parallel to resistor R1. P/N 101766-037 CAP. CER, .01 μ F +80, -20% 25V.

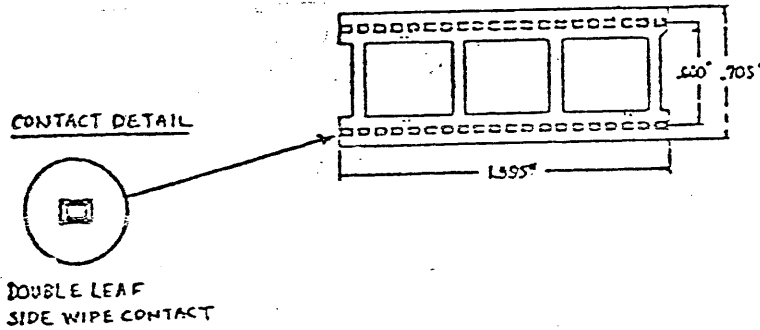
ECO 2-4578

1. Remove 40 pin IC's at locations A1 (8271), A20 (8275), A58 (8257), A69 (8080A-2), and A72 (8741-4).
2. Inspect 40 pin sockets for the type shown below:

If PWA does not have this type of socket, replace IC's in sockets (sockets are the correct type).

3. If PWA does have the above sockets, remove all 40-pin sockets shown above.
4. Replace 40 pin sockets with Intel P/N 102989-001.
5. Replace IC's in sockets.

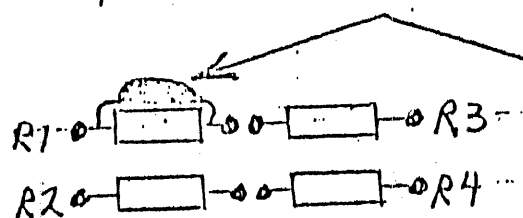
12 ADD CAPACITOR IN.
PARALLEL TO R1

STEP 12 ADD CAPACITOR C-90 IN PARALLEL TO RESISTOR R1.
P/N. 64-007 CAP. CER, .01UF $\pm 20\%$ 25V.

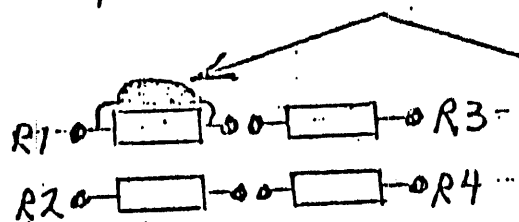
12 ADD CAPACITOR IN
PARALLEL TO R1

STEP 12 ADD CAPACITOR C-90 IN PARALLEL TO RESISTOR R1.
P/N. 64-007 CAP. CER, .01UF $\pm \frac{80}{20}\%$ 25V.

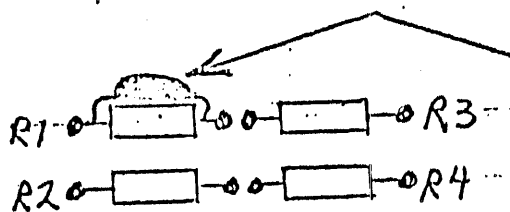
12 ADD CAPACITOR IN.
PARALLEL TO R1

STEP 12 ADD CAPACITOR C-90 IN PARALLEL TO RESISTOR R1.
P/N. 64-007 CAP. CER, .01UF $\pm 80\%$ 25V.
