intel® Technical Advisory

TA-0341-4

January 21, 2001

SKA4/SRKA4/SPKA4/ISP4400 Erratum Regarding 66 MHz PCI Bus Operation.

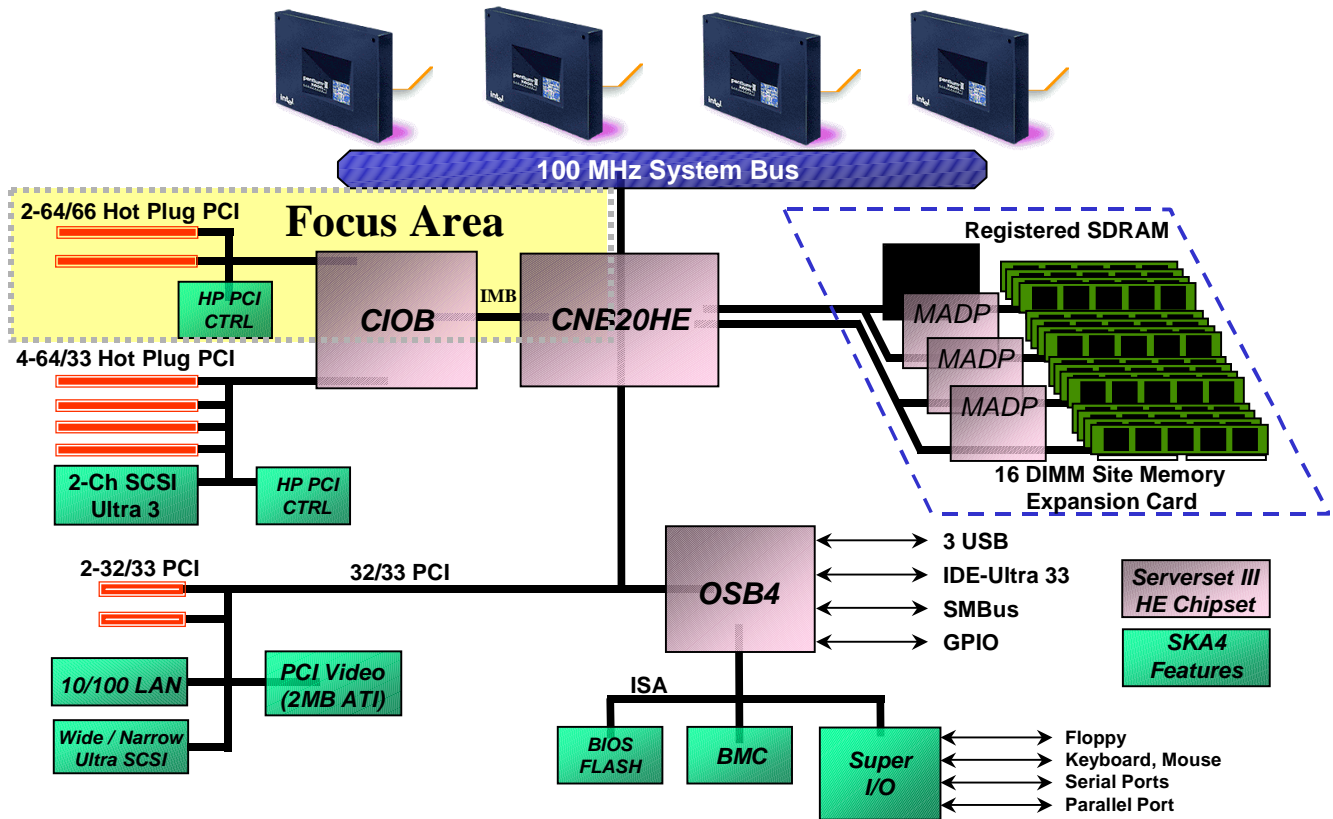
SKA4 Baseboard and MEC Block Diagram

The configurations under which the IO errors could be observed are isolated only to 66 MHz operation of the two baseboard 66 MHz capable PCI slots (PCI-A) and are independent of the operating system or 66 MHz adapter used. This issue does not apply to the six 33 MHz slots (PCI-B and PCI-C) and does not apply when the two 66 MHz slots are operating at 33 MHz. Please refer to the attached *SKA4 Baseboard and MEC Block Diagram*.

As a workaround, Intel is providing a feature in BIOS that automatically configures the two 66 MHz capable PCI slots to run at 33 MHz. Implementing this workaround will ensure the two 66 MHz capable slots operate at 33 MHz even if populated with 66 MHz capable adapters. Extensive test results show that the IO error associated with the sighting is not exhibited when the two 66 MHz capable slots on the SKA4 server board are operated at 33 MHz. Note that workarounds are not fully validated until root-cause is determined.
