Intel[®] Server RAID Controller U3-1 (SRCU31)

Specification Update

December 2000

Order Number: 273398-006

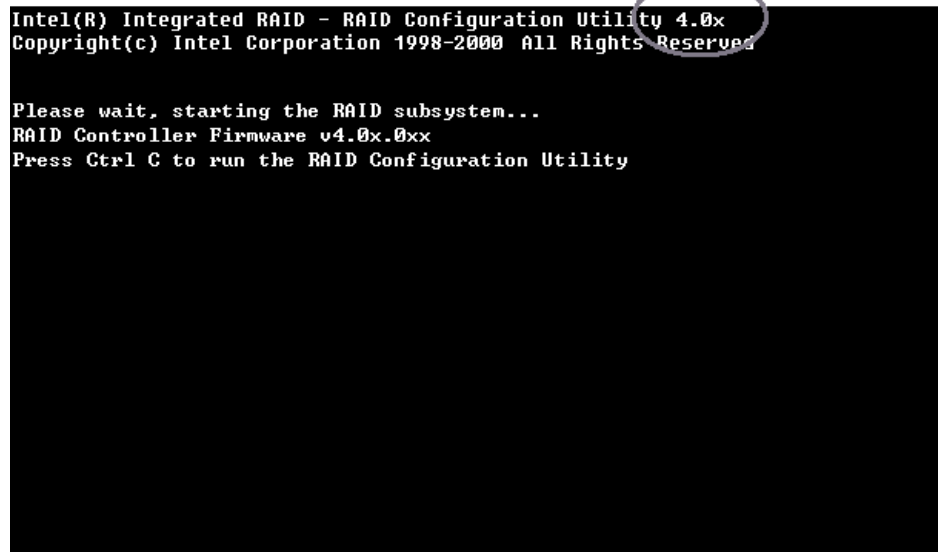
Figure 3. RCU Version

During the system boot process, the RAID Controller firmware initializes the RAID Configuration Utility. The end of the first line on the screen shown in Figure 3 displays the RCU version number.
