# Brocade Fabric OS v5.0.5a Release Notes v1.0

July 19, 2006

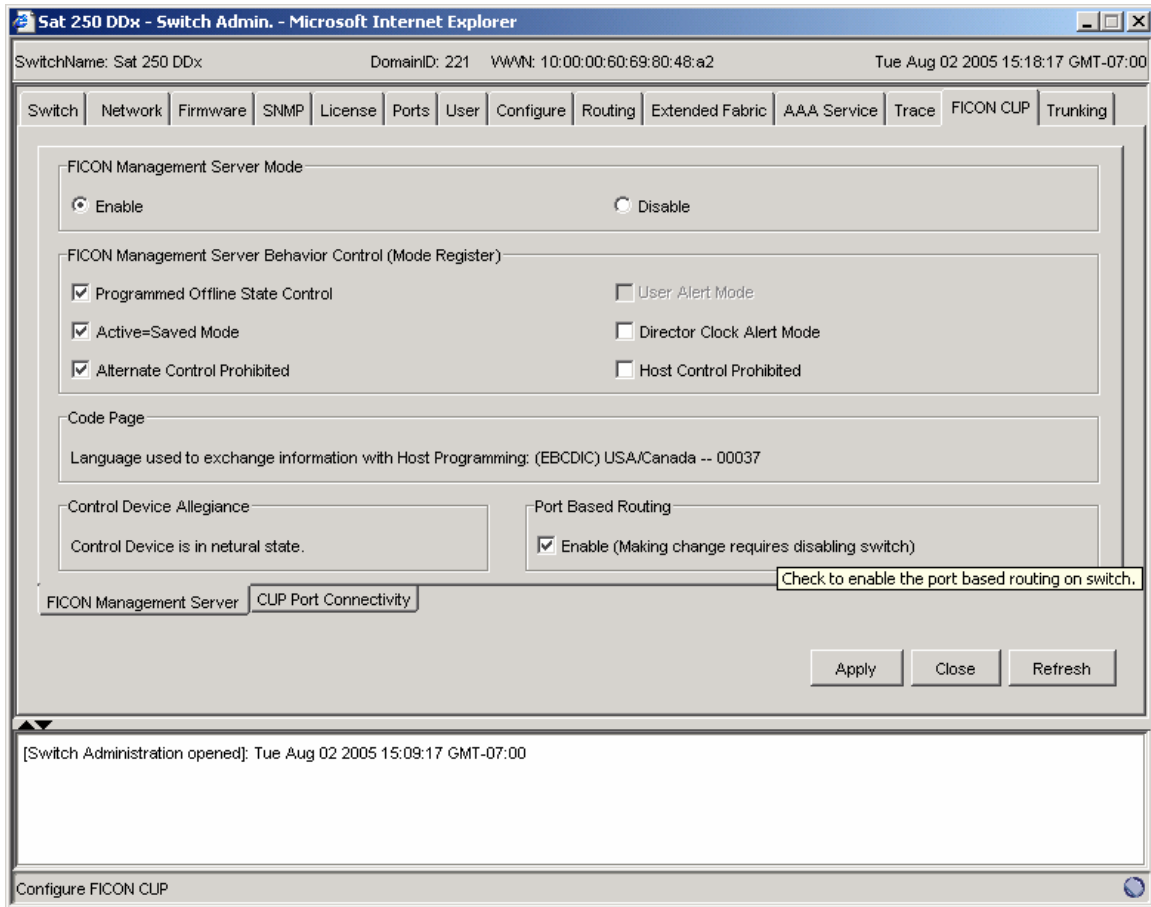
**Figure 12-1** FICON CUP Management, Port Based Routing.

The FICON CUP tab displays, with the FICON Management Server subtab in front, as shown in Figure 12-1.

4. Click the **Enable** radio button to enable the port-based routing policy.

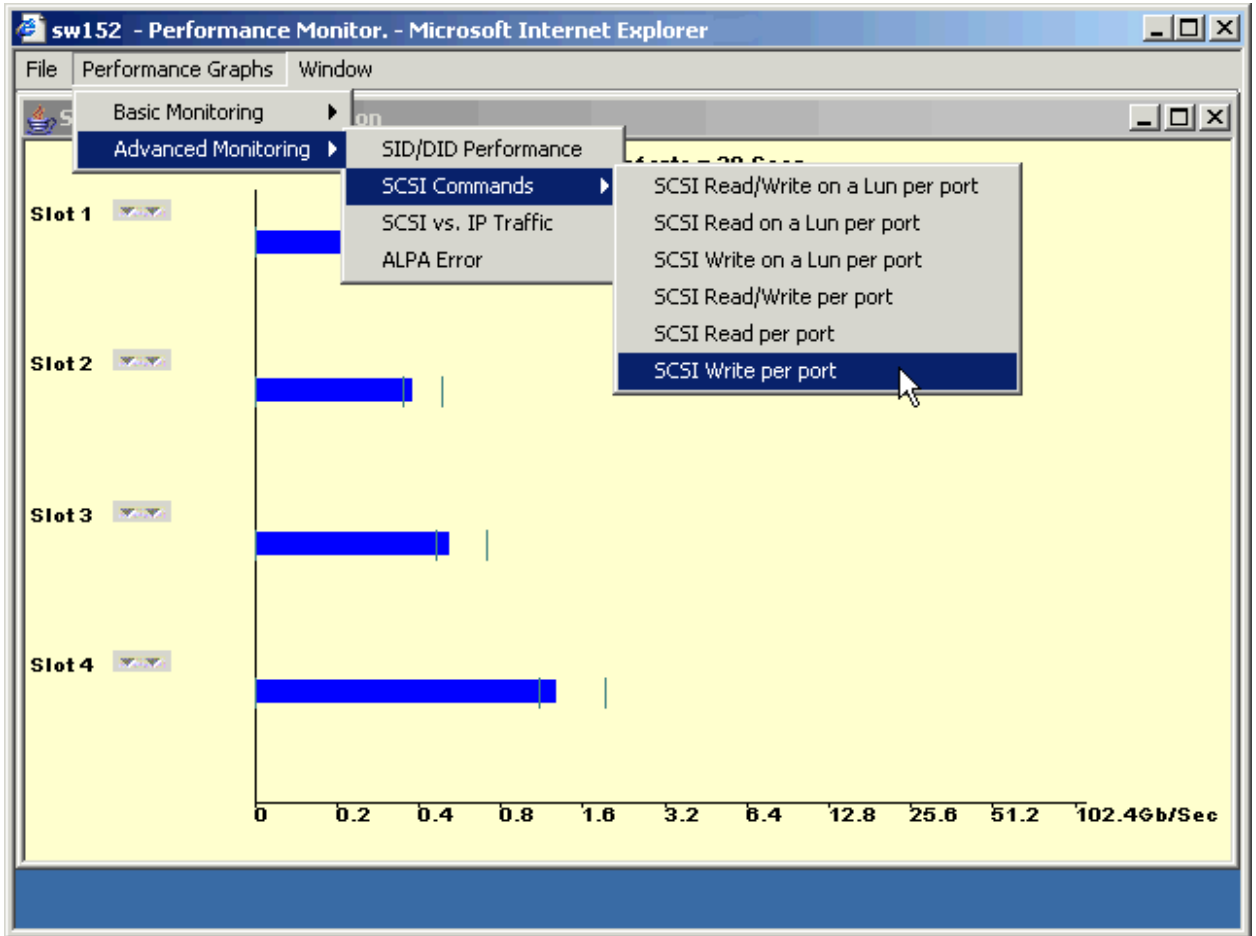
**Figure 14-1** Accessing Performance Graphs

Port throughput utilization is represented by a horizontal bar for each selected port, which gets longer or shorter depending on the percent utilization for that port at the last poll time. Thin short vertical intersecting bars give a historical perspective by representing the highest and lowest values reached for each selected port since the graph was opened. A third bar between them represents the average of all values polled. (See Figure 14-1.)

On page 14-3, replace Figure 14-1 with this one:
